Plan to Improve Corridors and Neighborhood Connections in Baldwin Park

Errata Sheet

Updated February 28, 2011

This document describes the errata for *Plan to Improve Corridors and Neighborhood Connections in Baldwin Park: A Report to the City of Baldwin Park*, printed November, 2010.

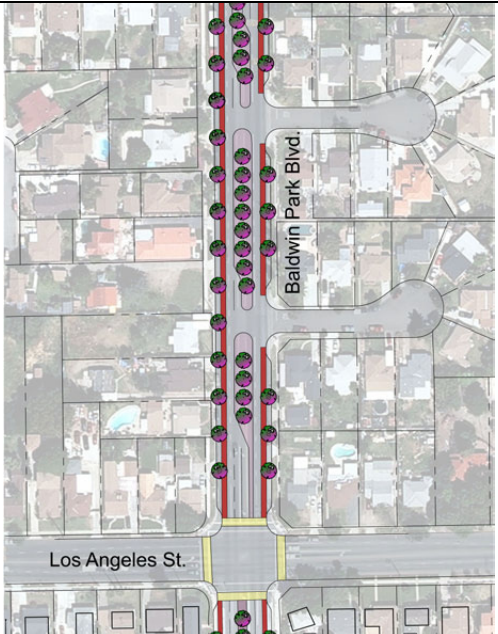
Page	Location	Change	
14	Drawing for 1.2. Baldwin Park Boulevard north of Los Angeles Street	The base aerial view used in the drawing was based on an incorrect location. It was redrawn based on the correct base aerial view.

An aerial photograph showing the intersection of Baldwin Park Blvd and Los Angeles St. The drawing overlays the photograph with proposed improvements, including a red double-line corridor along Baldwin Park Blvd, green circular markers representing trees, and a yellow highlighted area at the intersection. The text 'Baldwin Park Blvd.' and 'Los Angeles St.' are visible on the image.

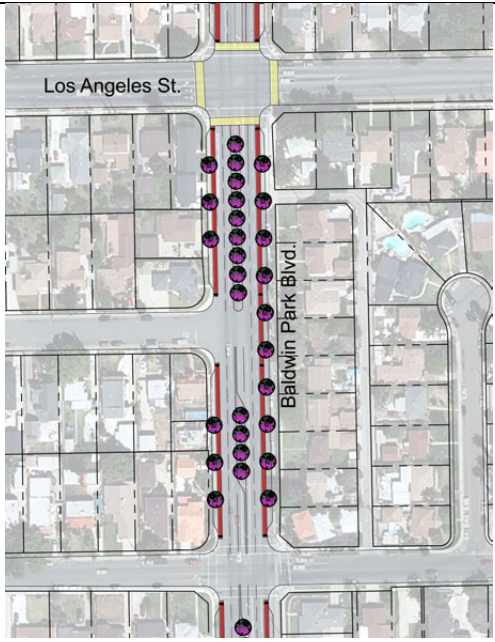
Page	Location	Change	
16	Drawing for 1.3. <i>South of Los Angeles Street to Ramona Boulevard</i>	The base aerial view used in the drawing was based on an incorrect location and showed a road diet with only one travel lane in each direction. It was redrawn based on the correct base aerial view and correctly showing two travel-lanes in each direction.
